LITTLE CHOCONUT WATERSHED SITE 2B DAM

**BROOME COUNTY, NEW YORK
INVENTORY No. NY 721**

PHASE I INSPECTION REPORT NATIONAL DAM SAFETY PROGRAM

**NEW YORK DISTRICT, CORPS OF ENGINEERS
FEBRUARY 1981**

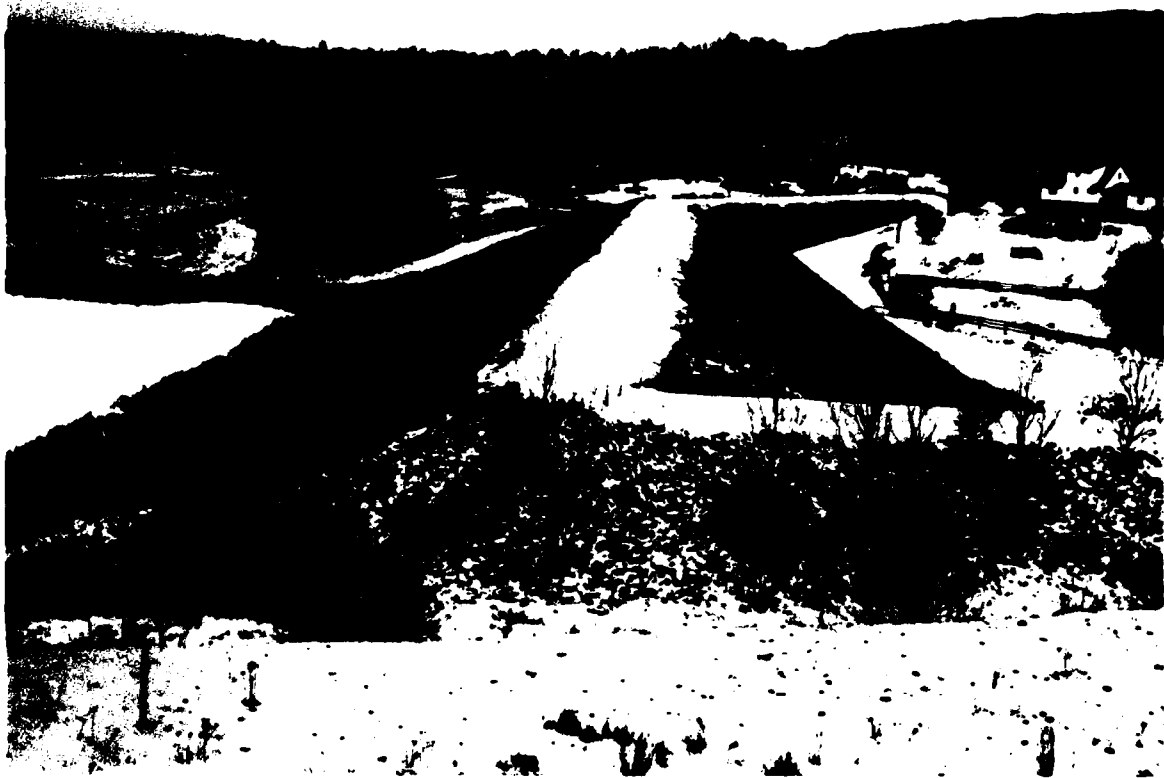
PHOTO #1: Overview of
Little Choconut Watershed Site 2B Dam
Inventory No. NY 721

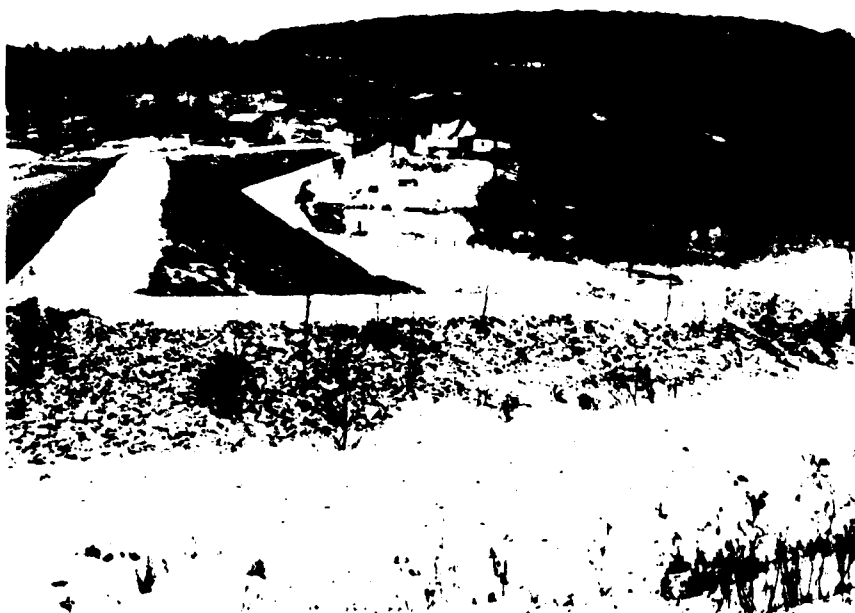
PHOTO #9: Riprap and rockfill bank of the emergency spillway

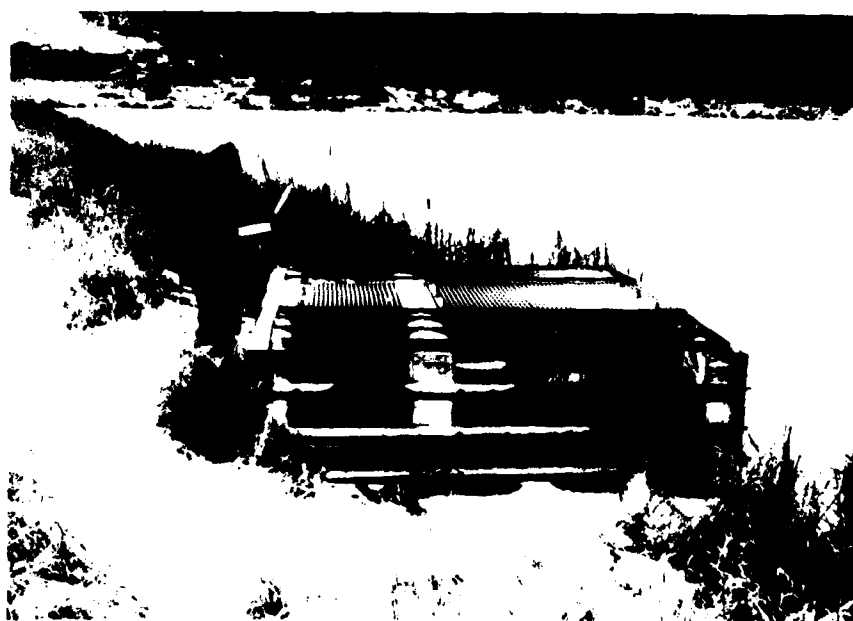
PHOTO #11: Drop inlet structure

The reinforced concrete drop inlet structure is in excellent condition (See Photo No. 11). The inlet weir has a trash rack attached to it and was free of debris. A gate stem for a lower level inlet was observed but not operated during the inspection.

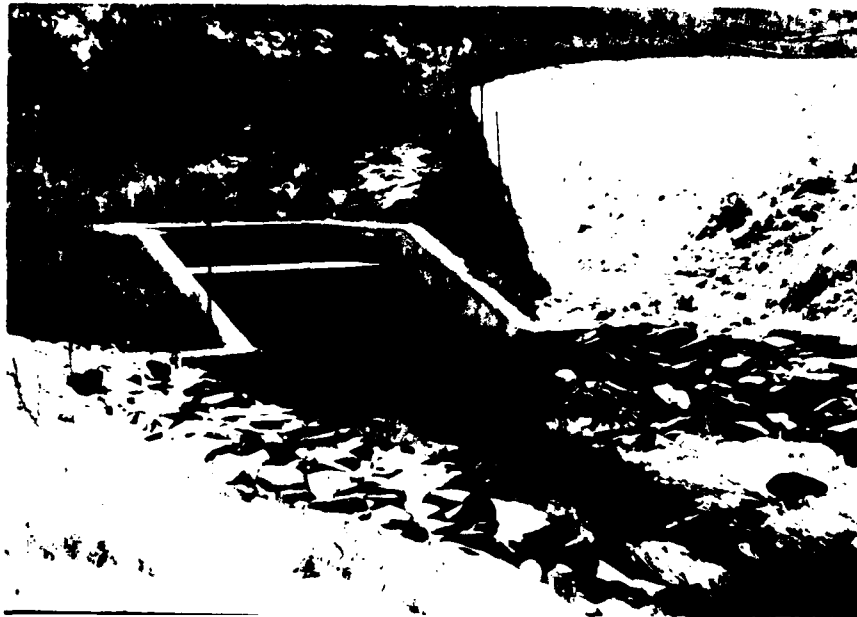
PHOTO #12: Outlet works: Impact basin

The principal spillway conduit discharges at a reinforced concrete impact basin used to dissipate the energy of high velocity discharge. Overall, the structure was in excellent condition (See Photo No. 12); however, some loose riprap has accumulated on the downstream concrete apron and the joint filler between the 30 inch PCCP and the impact basin has deteriorated.
